## APPENDIX 2. EUPHORBIA PERPLEXA VAR. KASAMANA, MWELA ROCK HERITAGE SITE

The detailed analysis during the Zambia Tanzania Interconnector Project (ZTIP) Environmental and Social Impact Assessment (ESIA) update led to the identification of a critical habitat for the *Euphorbia perplexa* var. *Kasamana*, an endangered Cactus species. This critical habitat is located in the Mwela Rock Art Site, which is part of the Kasama Forest Reserve, and a heritage site under the charge of the National Heritage Conservation Commission (NHCC). The transmission line is proposed to traverse this critical habitat for a distance of 2.3km as depicted in Figure 1.

# PROPOSED ZTIP KASAMA–NAKONDE WAYLEAVE TRAVERSING THE ROCK OUTCROP (EUPHORBIA PERPLEXA) AREA IN KASAMA DISTRICT

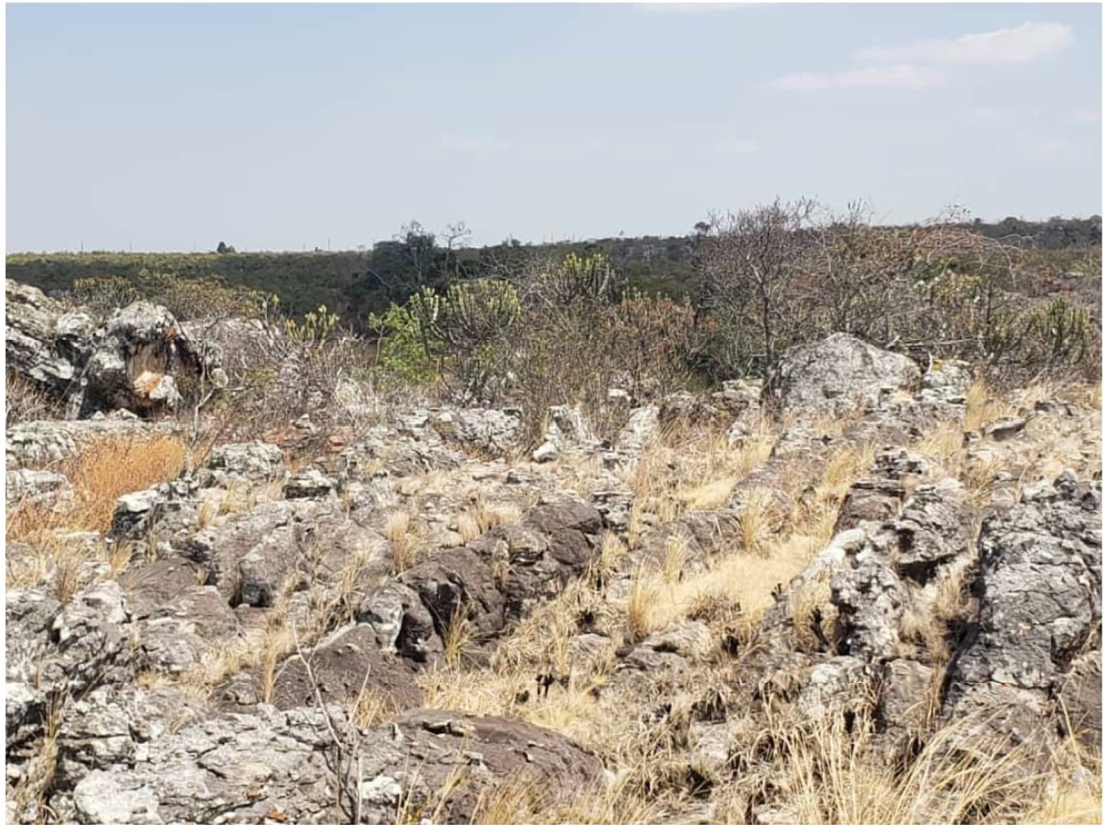
***Rock outcrops with Cactus in the proposed wayleave***

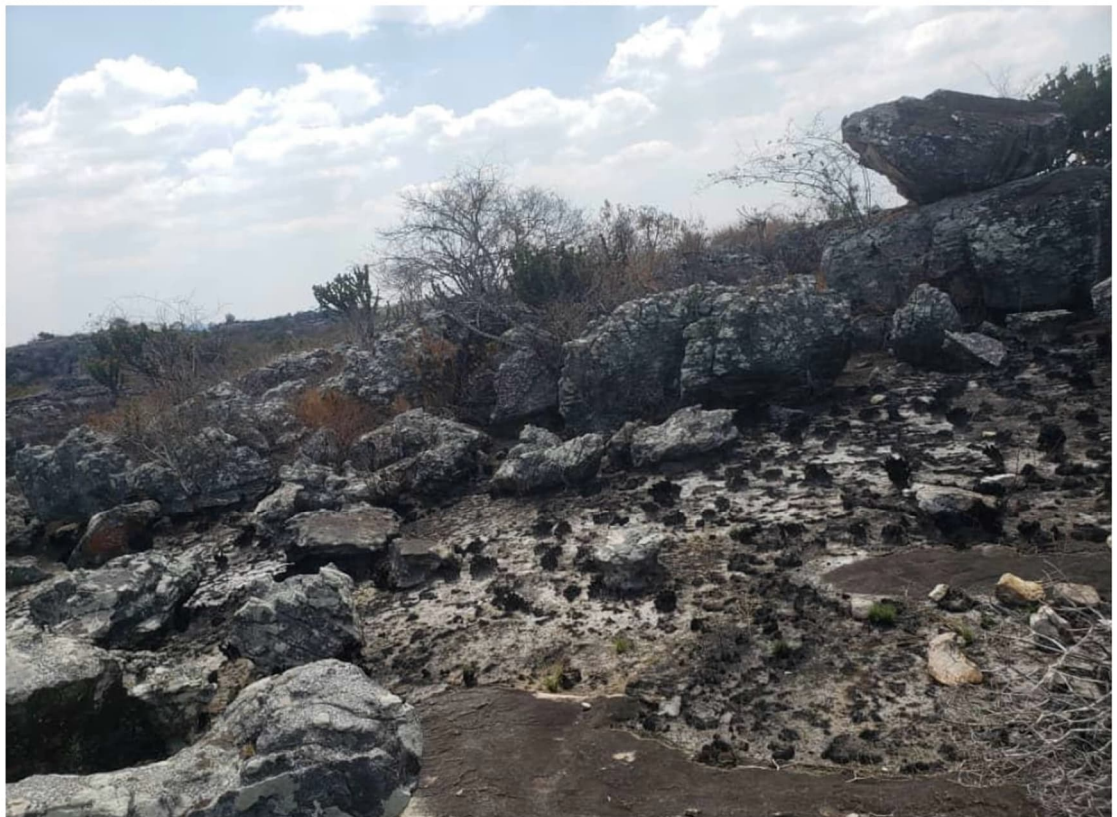
***Rocky terrain in the proposed wayleave***

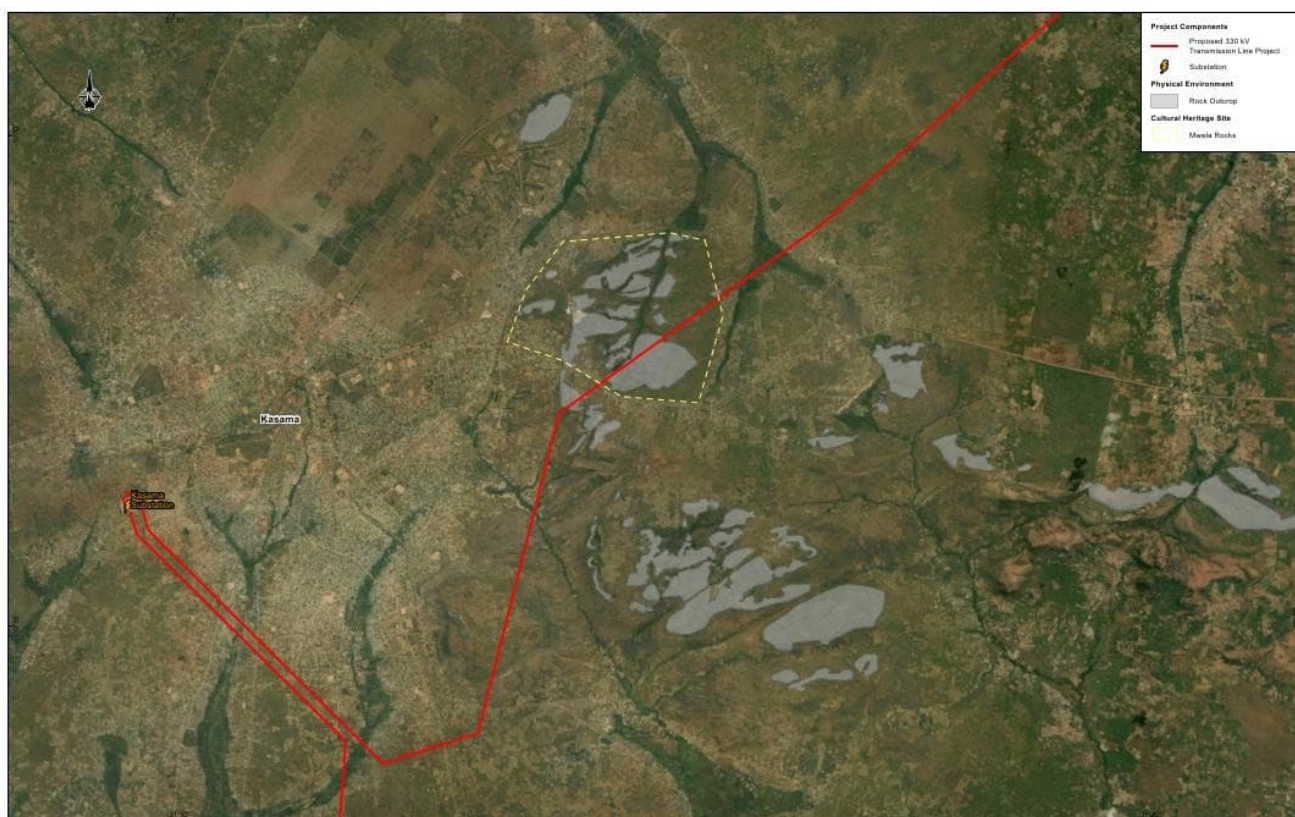
Figure 1: Proposed Routing of the ZTIP Transmission Line in the Mwela Rock Art Site

Figure 1 shows that the rock outcrops in the Mwela Rock Art site extend south and north of the transmission line. Southwards, exiting the Mwela Rock site, is the D18 Road, beyond which are settlements (Appendix 1).

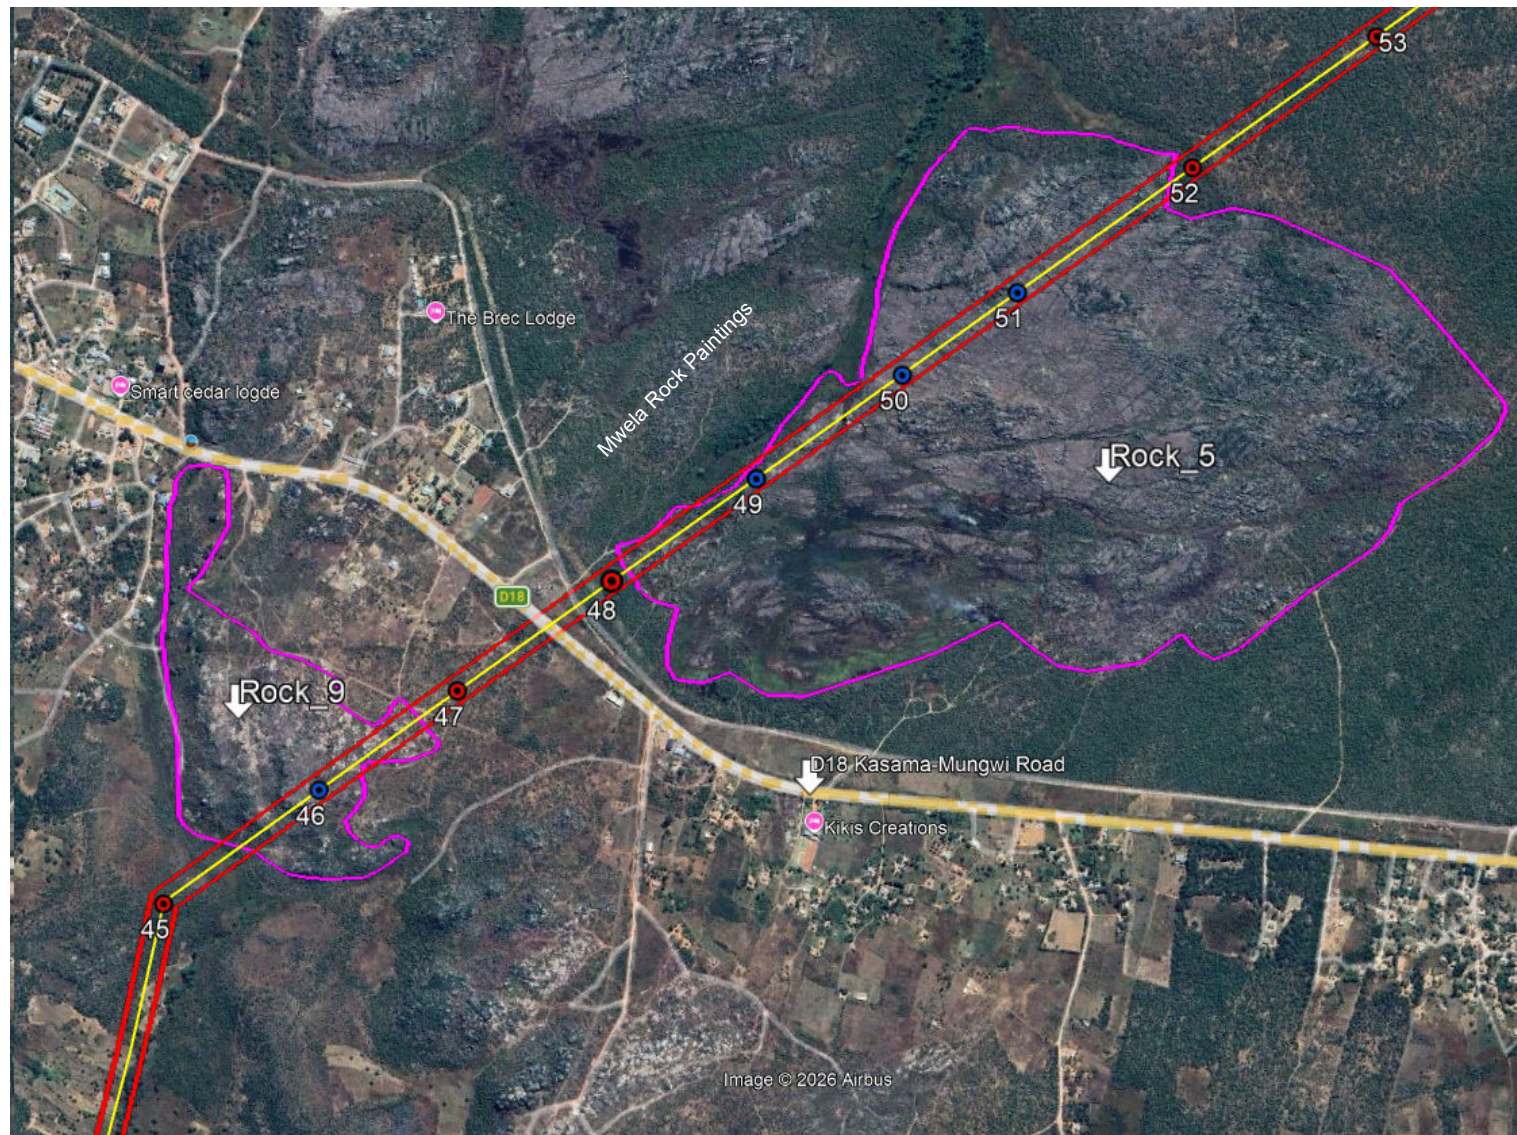
THE MAP DEPICTS THE PROPOSED ZAMBIA–TANZANIA INTERCONNECTOR PROJECT (ZTIP) WAYLEAVE ALONG THE KASAMA–NAKONDE CORRIDOR TRAVERSING TWO (2) ROCK OUTCROPS ROCK 5 AND ROCK 9.

TO REDUCE THE TOWER FOOTPRINT WITHIN BOTH ROCK OUTCROPS, ROCK 9 WILL HAVE (1) TOWER WHILE ROCK 5 WILL HAVE (3) TOWER LOCATIONS

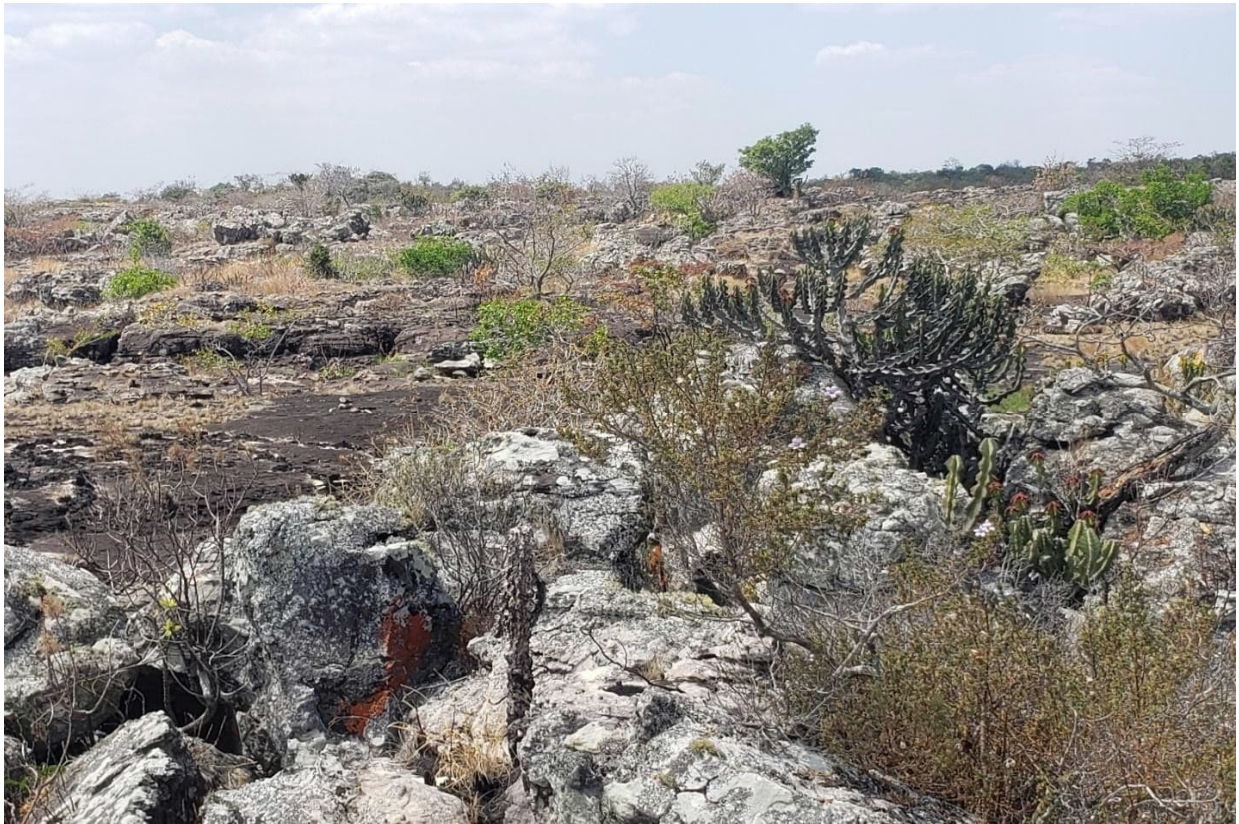
*Sparsely Distributed Euphorbia in the Proposed Wayleave*

- The Cactus species found on the outcrops have a characteristic height of not more than 1m and are sparsely distributed on the rocky outcrops that are spread across the site. (Appendix 3).

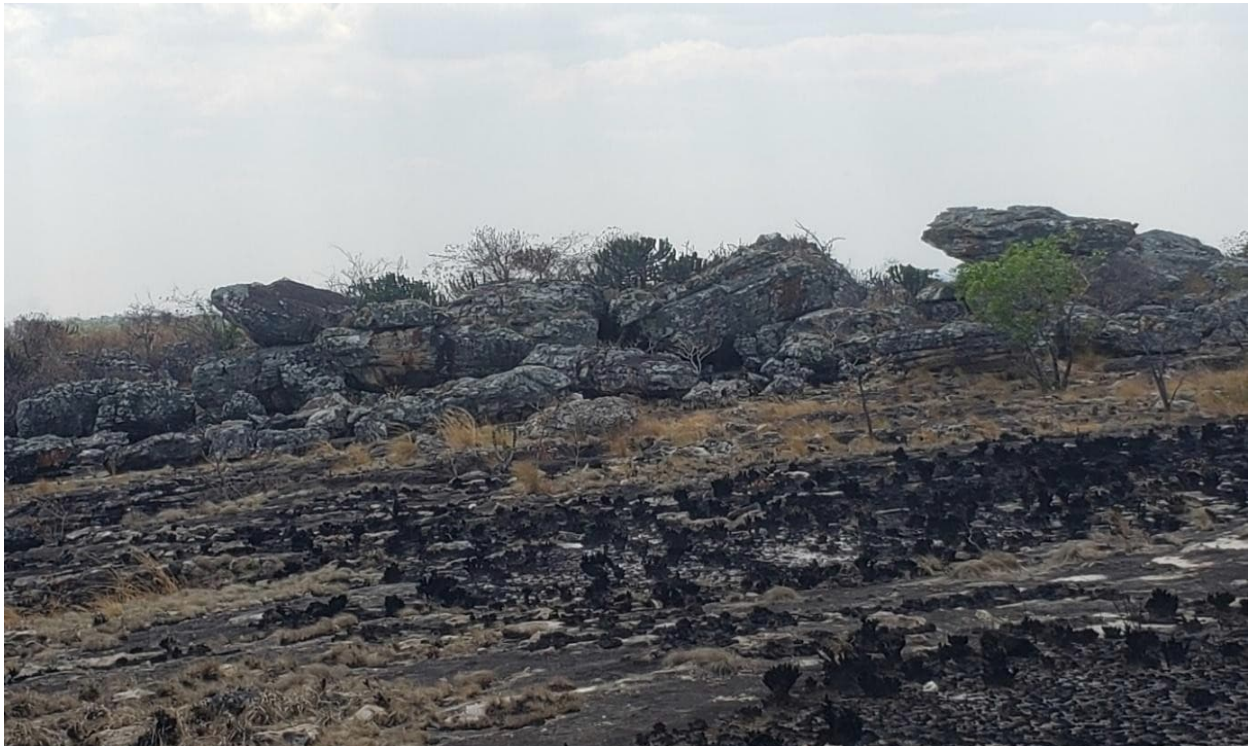
*Rocky Terrain in the proposed wayleave*

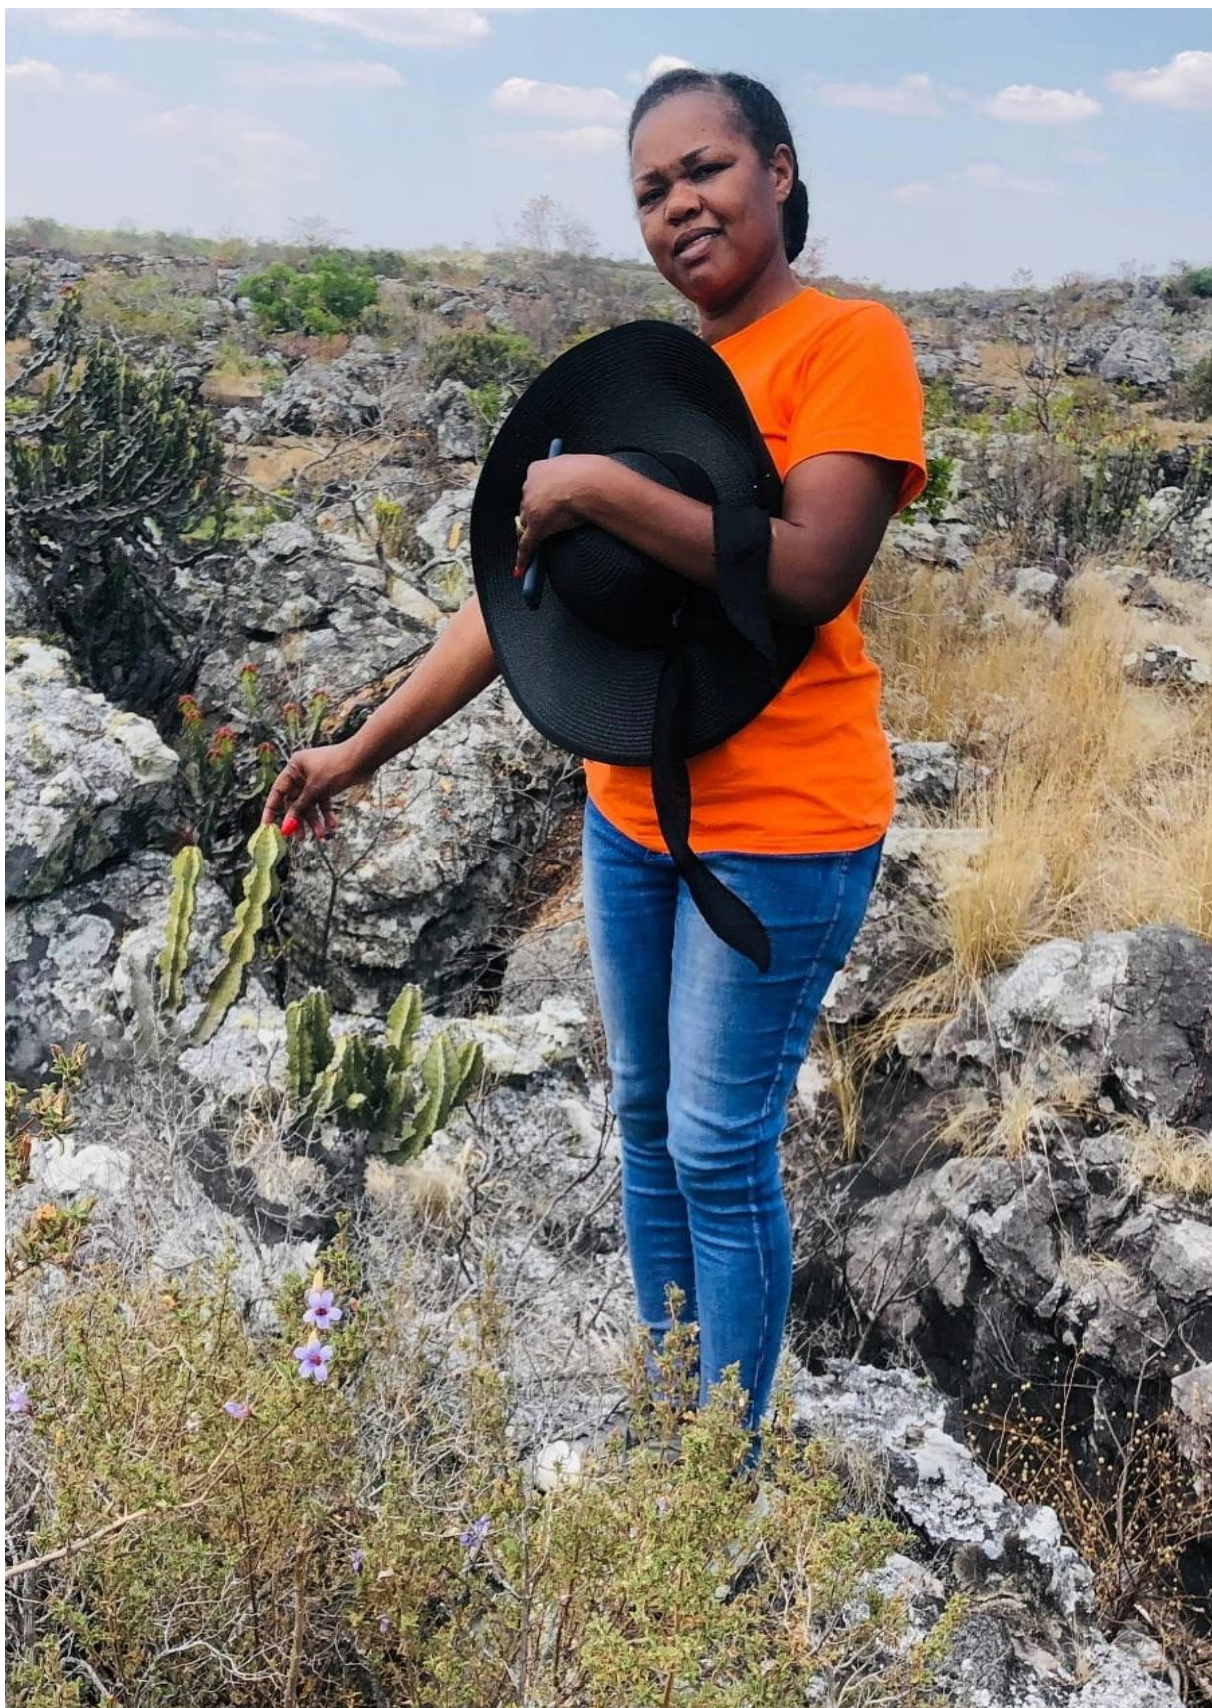
*Depiction of average height of Euphorbia within the proposed wayleave*

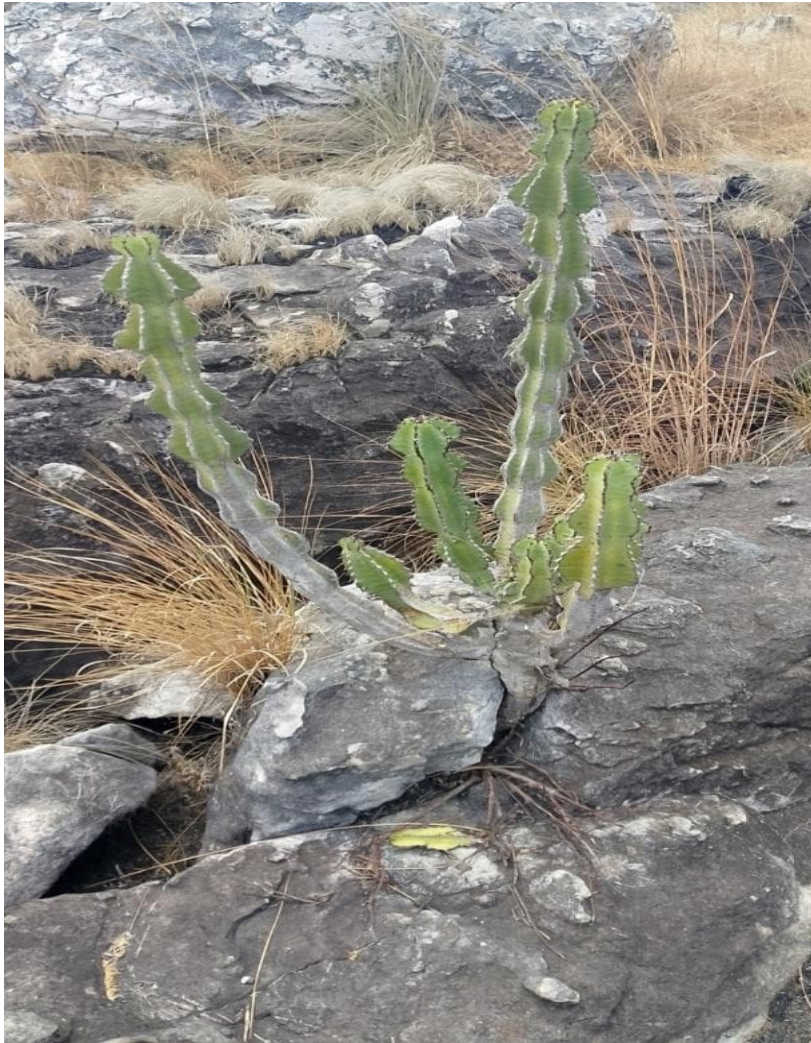
*Euphorbia on rock outcrop in the proposed wayleave*

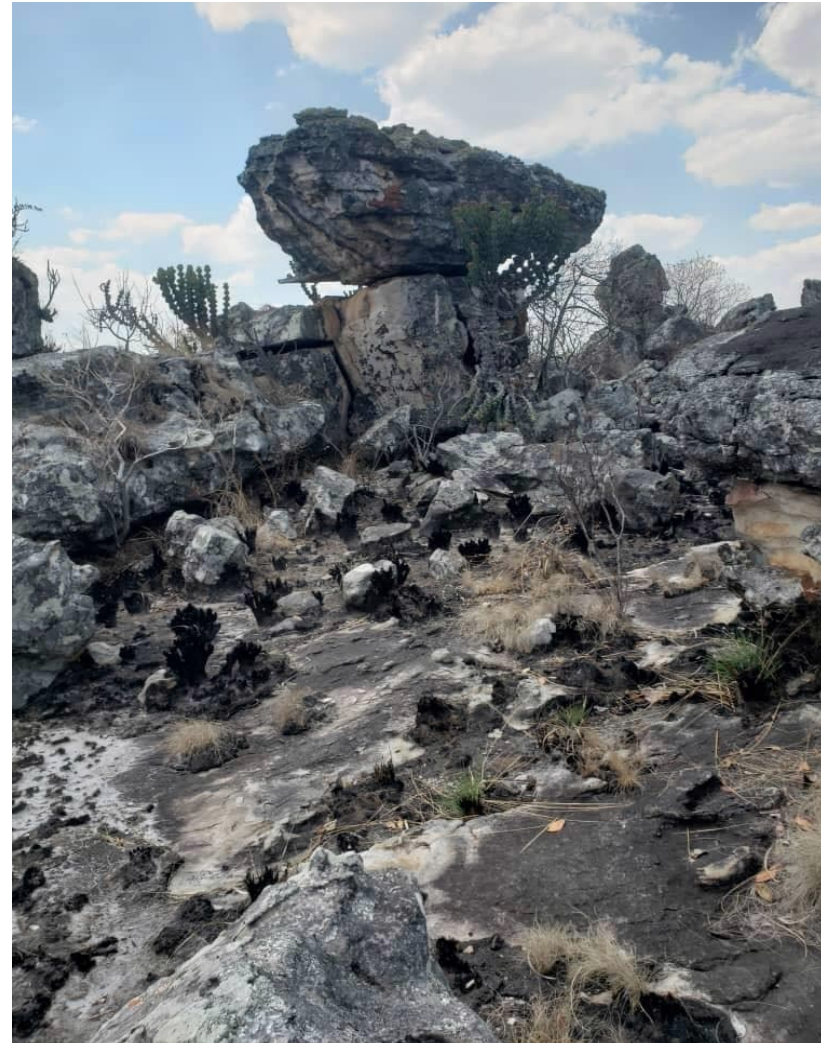
*Rocky terrain in the proposed wayleave*

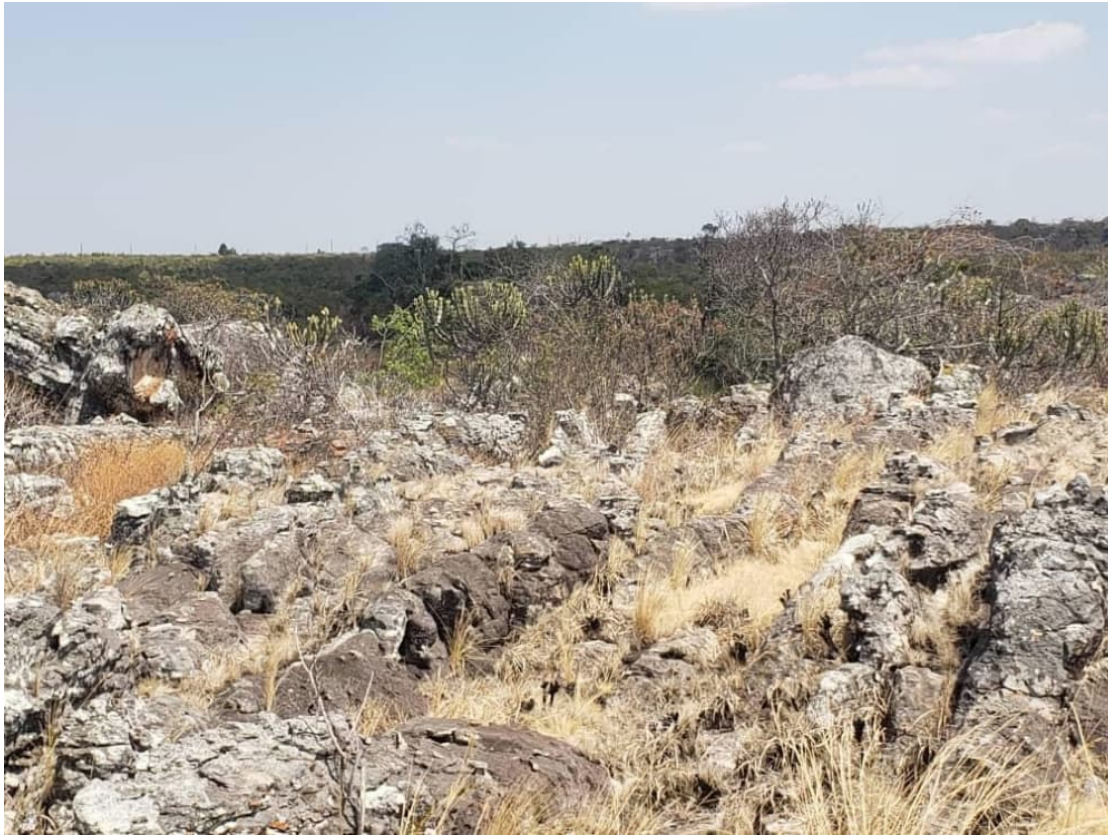
*Rock outcrops with Euphorbia in the proposed wayleave*

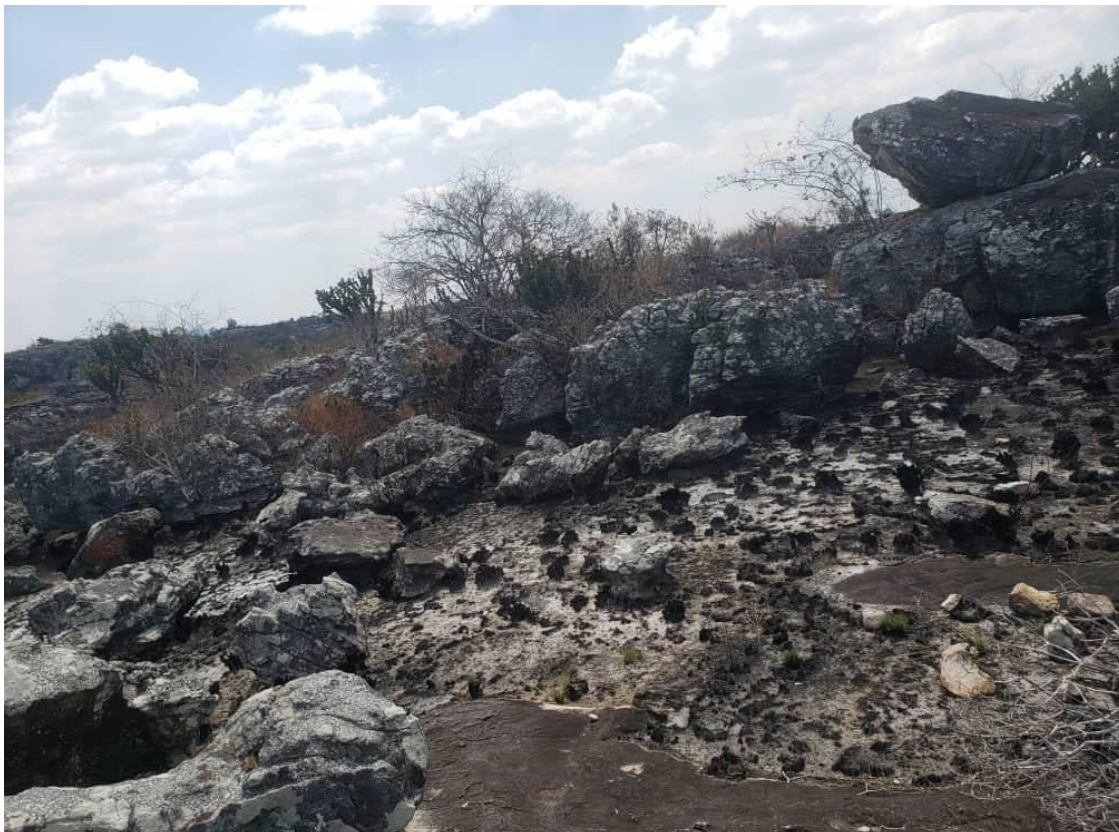
*Rocky terrain in the proposed wayleave*
